Retrofitting of Disconnectors at Saltholme, UK

Client : Northern Power Grid, UK

Location : Saltholme Generation, Saltholme

Product: 145kV Double break Disconnector

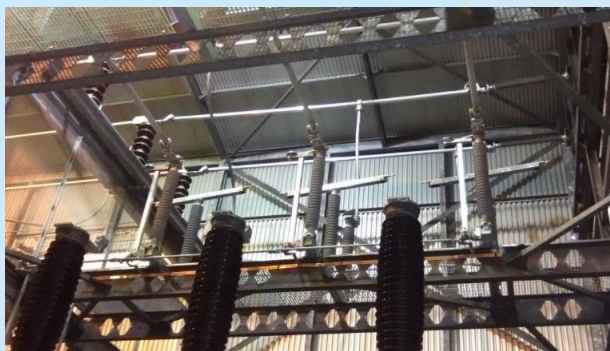
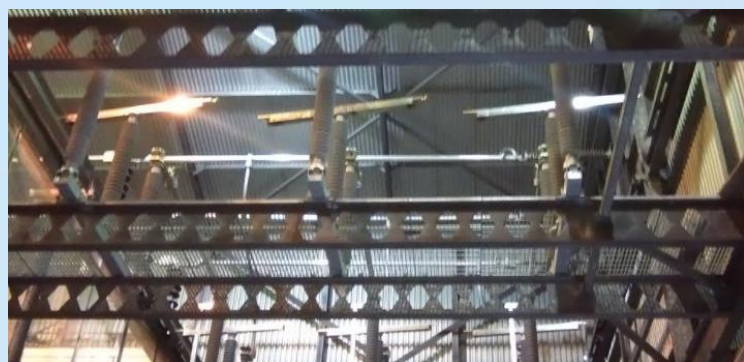
Before Retrofitting...

HAPAM Make Disconnector

- Aging of Disconnector change of Complete isolator including drive box due to Operation difficulty

- New enhanced Live parts replacement
- Installation as per customer requirement to match the Existing switch mounting position
