## Retrofitting of Disconnectors at GETCO, KADANA

**Client : GUJARAT ELECTRICITY TRANSMISSION CORPORATION**

**Location :KADANA HYDRO POWER STATION, GUJARAT**

**Product: 230kV Centre break Disconnector**

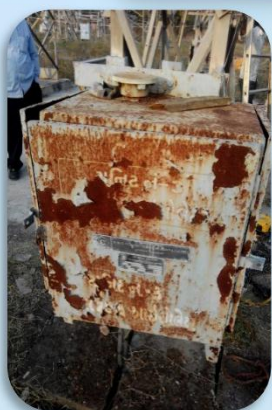
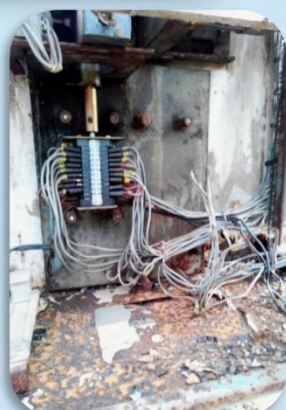
### Before Retrofitting...

**S&S Make Disconnector**

- Hard operation during Open/Close.
- Main contact Damage Hot Pits& Burns
- Rusting of Drive box and Water ingress in MS Drive box
- Contact Resistance increase.

- RC 230kV Moving blade changed without changing the other Accessories.
- Drive box (Aluminium) replacing existing MS Drive box.

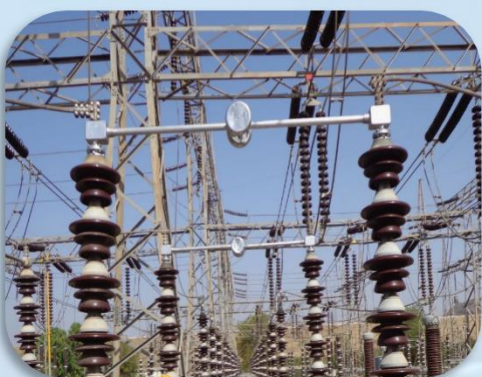
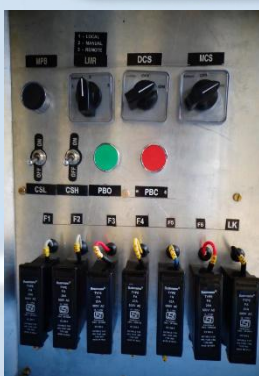
### After Retrofitting...

**S&S Make Disconnector**
