Retrofitting of Disconnectors at LANCO INFRATECH

Client : LANCO INFRATECH LIMITED

Location : UDIPI, INDIA

Product: 145kV Double break Disconnector

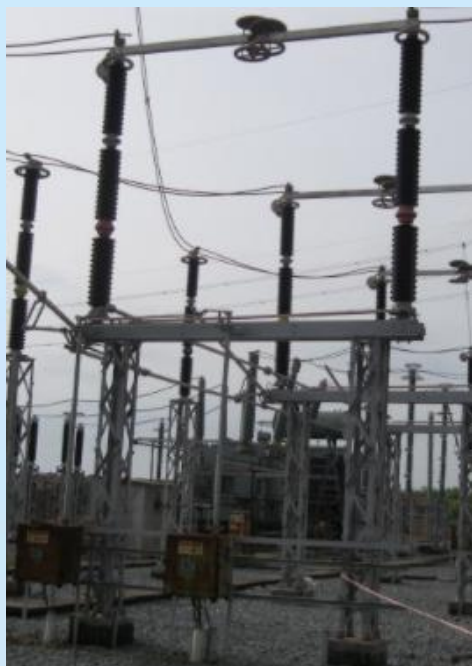
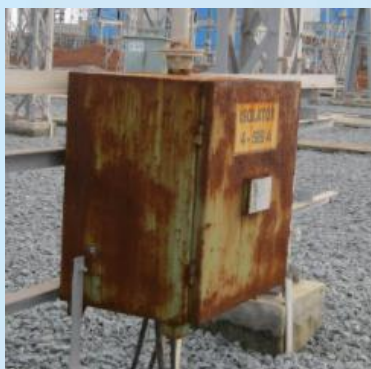
Before Retrofitting...

- Rusting of Drive box
- Hot spots in current carrying parts
- Hard in operation during Open/Close

AREVA Make Disconnector

- New enhanced Live parts replacement
- Drive box stainless steel and Terminal connectors towards site suitability

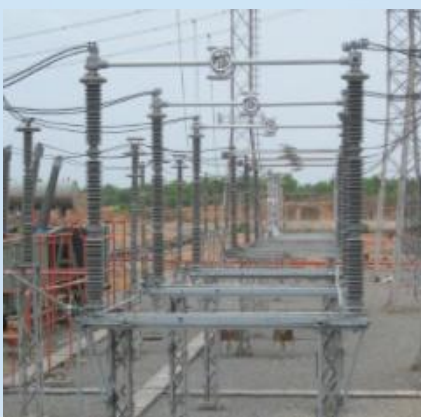
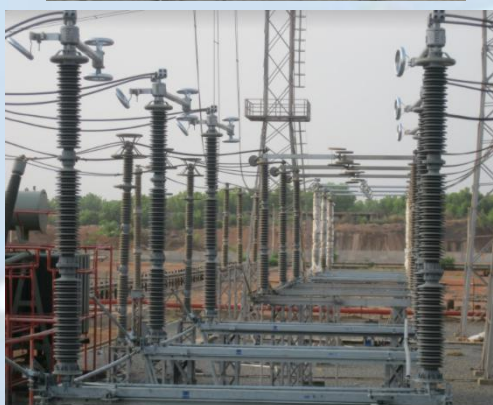
After Retrofitting...

S&S Make Disconnector
