Retrofitting of Disconnectors at SAIL, BHILAI

Client : STEEL AUTHORITY OF INDIA LIMITED

Location : MSDS-II & III – PSD - II

Product: 145kV Centre break Disconnector

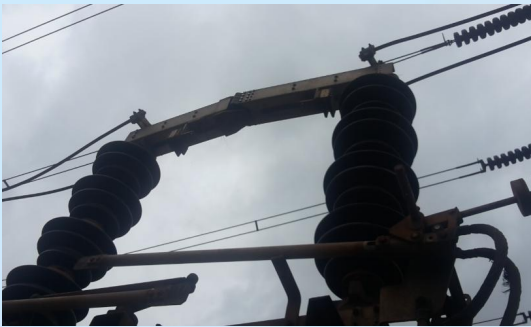
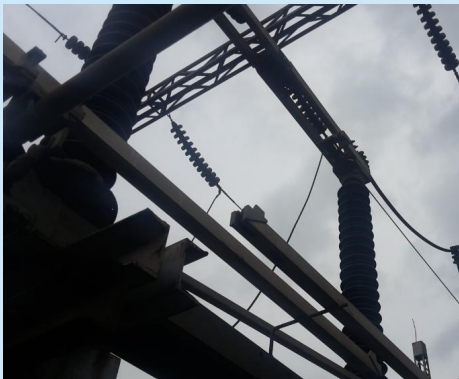
Before Retrofitting...

AREVA Make Disconnector

- Main contacts Damage / Hot spot pits and Burns
- Operation Hardness during Open /Close and some Drive boxes not in operating condition.

- New enhanced Live parts replacement
- Existing Drive boxes non-operative Replaced with New S&S Make Drive box

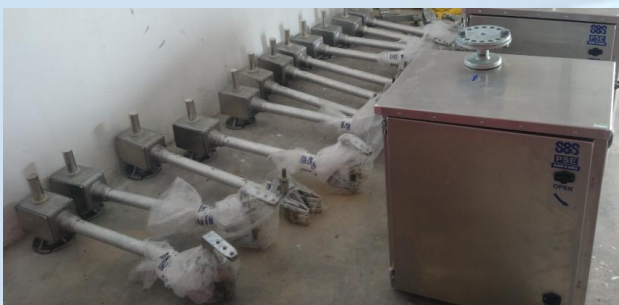
S&S Make Disconnector
