Retrofitting of Disconnectors at PGCIL, Kolar

Client : POWER GRID CORPORATION OF INDIA LIMITED, KOLAR

Location : KOLAR, KARNATAKA

Product: 420kV 2000A Centre break Disconnector

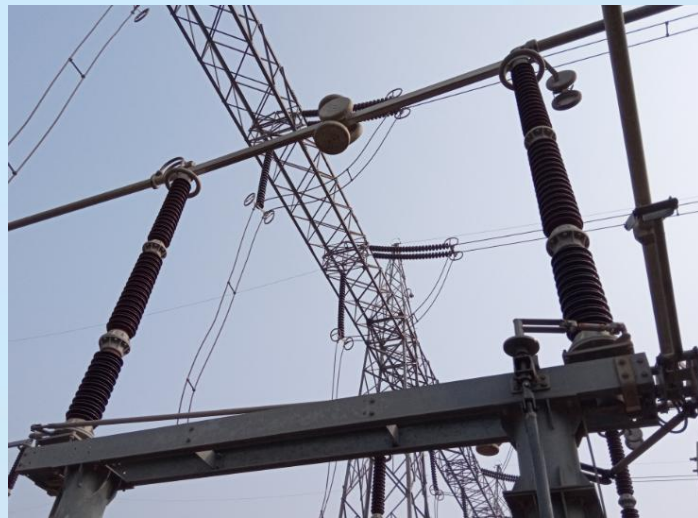
Before Retrofitting...

SIEMENS Make Disconnector

- Main contacts Hot spot pits and Burns
- Ageing of contacts due to old supply
